**Flood Control Project Maintenance  
Levee Inspections**

**Fall 2011 Levee Maintenance Deficiency Summary Report**

**Sutter Maintenance Yard Maintenance Area 0012**

**Levee Inspection Report By Mile - Fall 2011**

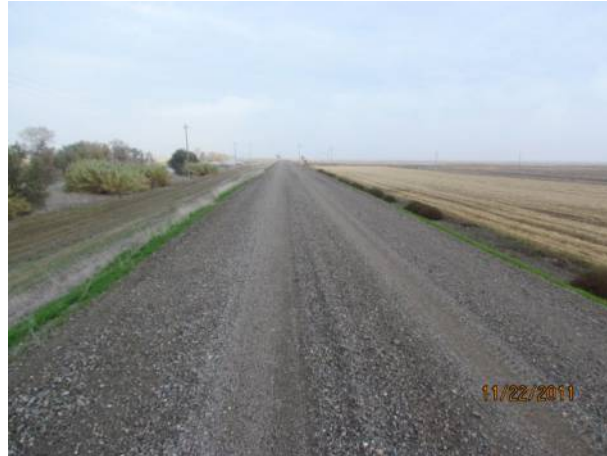
Levee Mile Report Line	4
Start Levee Mile	4.64
End Levee Mile	4.64
Location	Crown
Category	Earthen Levee
Item	Crown Surface / Depressions / Rutting
Sutter Yard placed new gravel on the crown roadway.	
rduffey_f_20111122_498.jpg

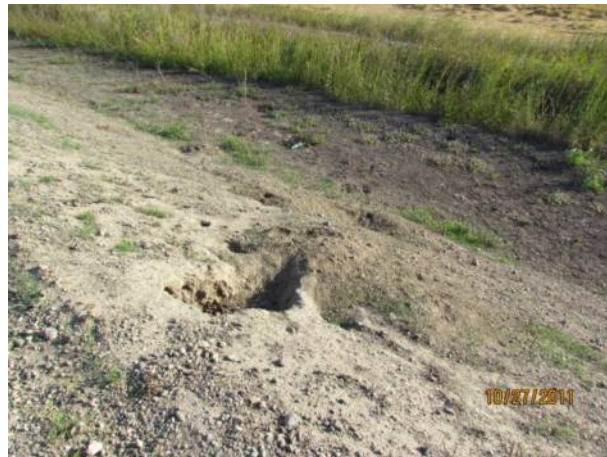
Levee Mile Report Line	6
Start Levee Mile	5.30
End Levee Mile	5.30
Location	Land Side
Category	Earthen Levee
Item	Animal Control
View of the rodent holes along the L/S slope.	
rduffey_f_20111128_510.jpg

6	5.30	5.30	Earthen Levee	Animal Control	LS	M	Exterminate rodents and backfill and compact or grout burrows.	39.103490 ° -122.016340 °	39.103490 ° -122.016340 °	206 Y
7	5.82	5.82	Earthen Levee	Animal Control	LS	M	No rodents visible, but rodent burrows visible; need to backfill and compact or grout burrows.	39.110742 ° -122.017342 °	39.110742 ° -122.017342 °	207 Y
8	7.66	7.68	Earthen Levee	Slope Stability	LS	C	Repair slope instability.	39.135813 ° -122.022782 °	39.136107 ° -122.022773 °	5
9	7.66	7.68	Earthen Levee	Slope Stability	LS	A	Repair slope instability. Inspector Comments: Repaired damaged slope.	39.135813 ° -122.022782 °	39.135813 ° -122.022782 °	209 Y
10	9.19	9.20	Supplemental	USACE Erosion Survey	WS	M	Inspector Comments: 2011: Erosion occurring upstream and downstream of an irrigation diversion structure. [2011 Site ID: SYC_9-3_L]	39.158226 ° -122.021950 °	39.157957 ° -122.021950 °	7 Y

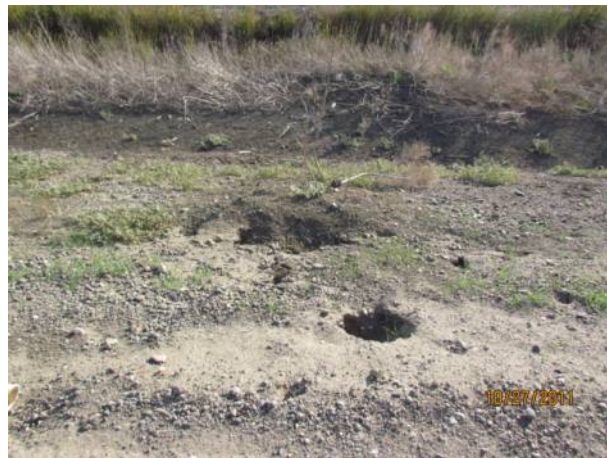
Levee Mile Report Line	7
Start Levee Mile	5.82
End Levee Mile	5.82
Location	Land Side
Category	Earthen Levee
Item	Animal Control
View of rodent holes along the L/S slope.	
rduffey_f_20111128_511.jpg

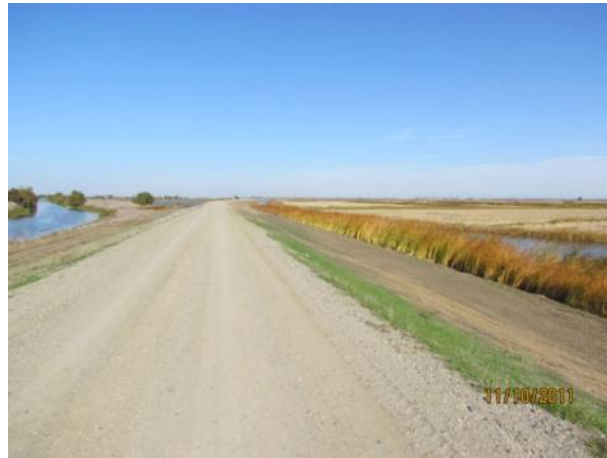
Levee Mile Report Line	9
Start Levee Mile	7.66
End Levee Mile	7.68
Location	Land Side
Category	Earthen Levee
Item	Slope Stability

View of the repaired site by Sutter Yard.

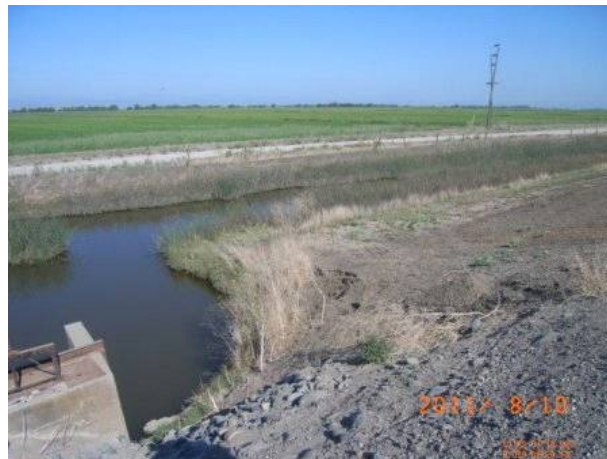
USACE 2011 Photo #1

Levee Mile Report Line	10
Start Levee Mile	9.19
End Levee Mile	9.20
Location	Water Side
Category	Supplemental
Item	USACE Erosion Survey

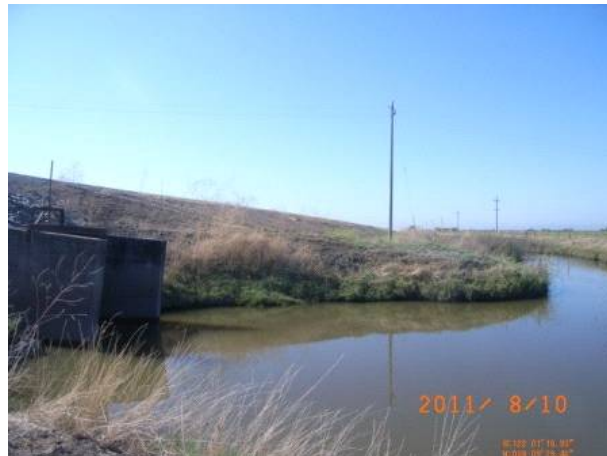
USACE 2011 Photo #2

Levee Mile Report Line	10
Start Levee Mile	9.19
End Levee Mile	9.20
Location	Water Side
Category	Supplemental
Item	USACE Erosion Survey

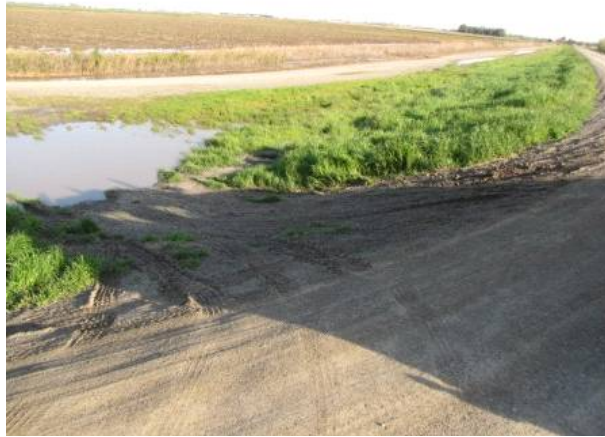
Levee Mile Report Line	11
Start Levee Mile	10.72
End Levee Mile	10.72
Location	Land Side
Category	Earthen Levee
Item	Slope Stability

View of vehicle erosion along the slope.

11	10.72	10.72	Earthen Levee	Slope Stability	LS	M	Repair the levee slope damaged by vehicle traffic and prevent access where possible.	39.173970 ° -122.014335 °	39.173970 ° -122.014335 °	6 Y
